# Service Bulletin

#10016583 September 29, 2005

## Service Alert: Potential for Water Contamination in Hub Lubricant Due to Flooding in South Central US

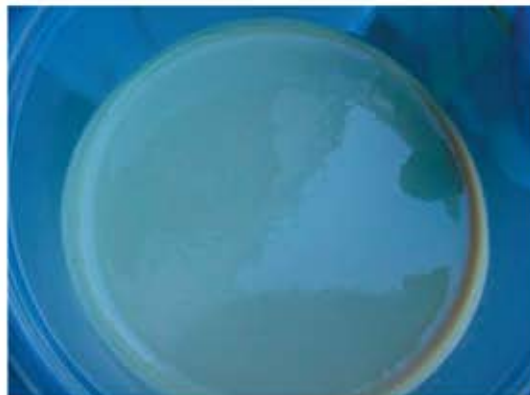
A visual inspection of the hub lubricant is advised. Oil, such as a 50 weight synthetic, with a small amount of water added will turn to become a milky white color (figure 1). Semi-fluid grease will also turn a milky color. However the color change will depend on the grease's base color. Figure 2 shows semi fluid grease after water contamination. Its base color was a red/pink color and after contamination the lubricant has turned a milky shade of pink.

**Figure 1:** 50 weight synthetic oil contaminated with a small amount of water turns milky white.

Contaminated lubricant should be removed from hub assembly and replaced with new lubricant. Hub cavity should be thoroughly cleaned to ensure removal of all contaminated lubricant.

Inspect bearing cups and cones for water corrosion, rusting and any unusual signs of wear. Replace bearings if necessary with appropriate bearing set.

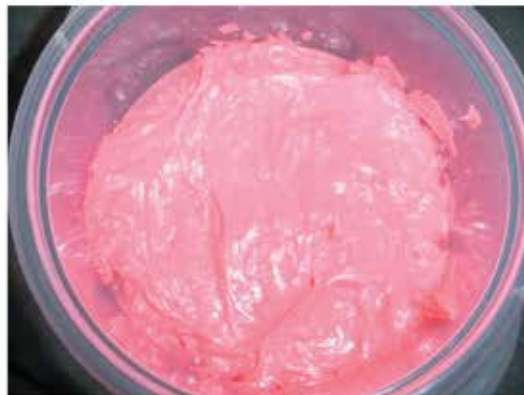
**Figure 2:** Red/pink semi-fluid grease contaminated with a small amount of water turns milky pink.
